**Flood Control Project Maintenance
Levee Inspections**

Fall 2016 Levee Maintenance Deficiency Summary Report

Sacramento River Basin

Sacramento River West Side Levee District

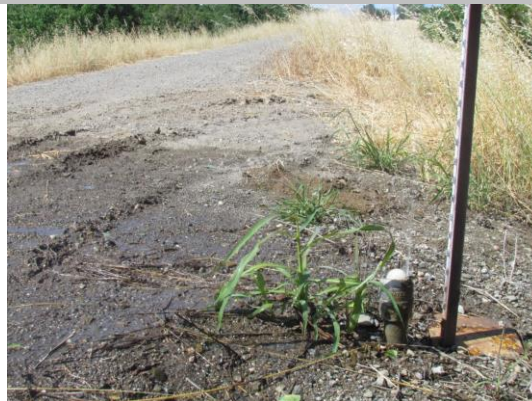
Photo 1 of 6 : FA_2016_NA0016_435_109_20160913_00048.jpg

LM Start	46.01	Rating **	M	Issue No.	109
LM End	46.01	Issue Type +	En	Location *	WS
Category	Earthen Levee			GPS Latitude/Longitude	
				Start	End
Item	Encroachments			39.187479 °	39.187479 °
				-121.962081 °	-121.962081 °
DWR ID	DWR_NA0016_01_s_2015_109				
Comment Code					
PI : Pipe					
Inspector Comment					
The siphon filter is fixed. There is no external leak on the levee from the pipe, however there are vegetation growing in line with the pipe. Update 3/16/2016: Seems some maintenance was done on pipe. Vegetation on top of pipe is removed.

View of the siphon breaker on the shoulder of the waterward side of the levee looking upstream. Spring 2015.

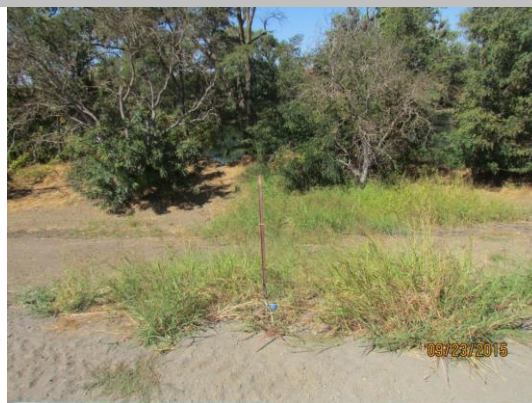
Photo 2 of 6 : FA_2016_NA0016_435_109_20160913_00049.jpg

Vegetation is aligned where the pipe is on the waterward side of the levee. Fall 2015.

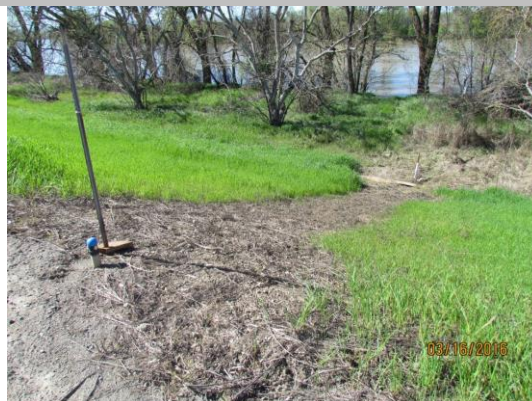
Photo 4 of 6 : FA_2016_NA0016_435_109_20160913_00051.jpg

Non-vegetated seems to align with the pipe. Spring 2016.

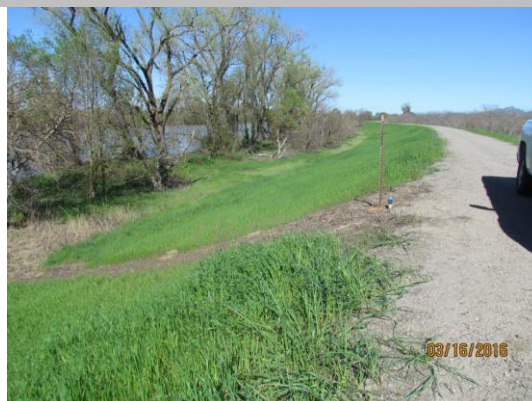
Photo 5 of 6 : FA_2016_NA0016_435_109_20160913_00052.jpg

Perspective view of the non-vegetated area where the pipe seems to run through the levee looking downstream. Spring 2016.

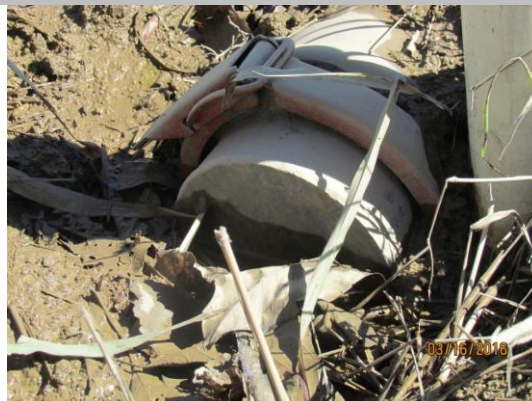
Photo 6 of 6 : FA_2016_NA0016_435_109_20160913_00053.jpg

Pipe seems to be capped off at the toe of the levee on the waterward side of the levee. Spring 2016.

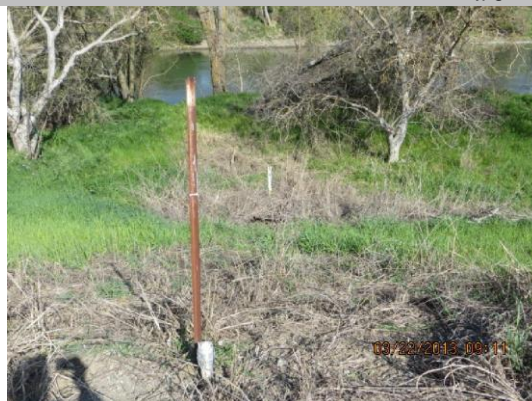
Photo 1 of 2 : UCIP_FA_2016_46812_17909.jpg

FS_ID:46812
DS_ID:20314
EP_NO: 15763
Repair Type: Non-Urgent
Crossing Status: Found
UCIP Comments: Fresno valve on WS shoulder is broken. Pipe appears to be abandoned. Need to abandon properly if necessary. site visit on 10/09/2015 indicates water is present somewhere along the waterside levee slope. Possibly siphon breaker or fresno valve sprays and drains down levee slope from WS shoulder. internal inspection of pipe recommended to determine source of leak. Pipe is active, but can be removed and capped when not in use.
FIELD_STRUCT_DESC: 4-inch galvanized steel irrigation pipe through levee 2.0 feet below crown. Irrigation valve approx. 50 feet landward of the landward levee toe. Fresno valve on WS shoulder with connection for pump at WS berm. (Permit No. 15763, 1992).
FS Date: 3/22/2013

Broken fresno valve on WS shoulder

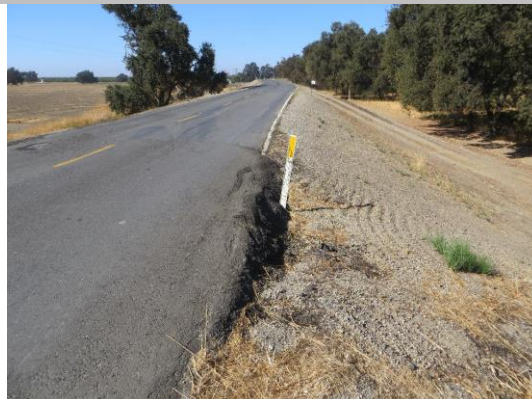
Photo 1 of 2 : UCIP_FA_2016_50044_74722.jpg

FS_ID:50044
DS_ID:20296
EP_NO: 5551
Repair Type: Urgent
Crossing Status: Found
UCIP Comments: 09/23/2016 - A second pipe is visible adjacent to the intake pipe. According to the permit drawings, this pipe is an access pipe for a submersible pump used to clean the fish screen by backwashing. hole on LS shoulder of the levee and Moon Bend Rd. has been patched. No additional road damage is visible. (T. Hatch/UCIP)

09/01/2016 no visible changes from previous inspection. - (T. Hatch/UCIP) 10/09/2015 Possible sink hole along alignment 10-feet LS of siphon breaker on LS slope. Recent road repair along the approximate pipe alignment suggests that levee slumping is related to pipe. It is recommended that further investigation e.g. video inspection or other internal method may help determine if the issue is due to pipe or due to levee settlement in vicinity of the pipe. (T. Hatch/UCIP)
FIELD_STRUCT_DESC: 18-inch steel irrigation pipe through the levee, 3 feet below the crown. Pump mounted on a piling structure on the waterside (WS) bank. A switch box is located on the WS shoulder and a siphon breaker is in a 30-inch corrugated metal riser on the landside (LS) shoulder. Pipe discharges into a concrete box at the toe of the LS slope (Permit issued under ABO No. 9349, 1974 - Davis). Pump and pump platform replaced under Permit No. 5551, 1968 - Davis. Fish screen installed under permit No. 17222, 2000- A&L Rental and Leasing. [Additional Reference(s): DWR Levee Logs, 2006].

Recent pavement repair showing levee slumping. Photo taken from WS looking upstream along Moon Bend Rd

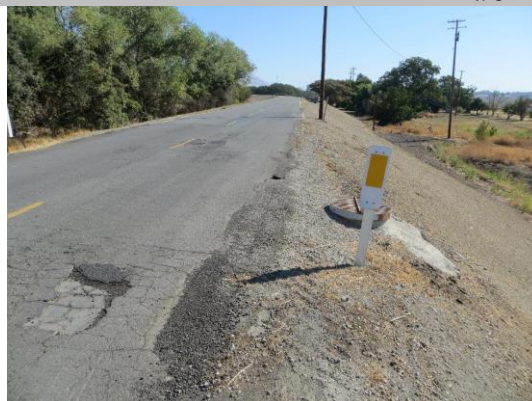
Photo 2 of 2 : UCIP_FA_2016_50044_74723.jpg

Comment Code					
Inspector Comment					
FS_ID:50044 DS_ID:20296 EP_NO: 5551 Repair Type: Urgent Crossing Status: Found UCIP Comments: 09/23/2016 - A second pipe is visible adjacent to the intake pipe. According to the permit drawings, this pipe is an access pipe for a submersible pump used to clean the fish screen by backwashing. hole on LS shoulder of the levee and Moon Bend Rd. has been patched. No additional road damage is visible. (T. Hatch/UCIP) 09/01/2016 no visible changes from previous inspection. - (T. Hatch/UCIP) 10/09/2015 Possible sink hole along alignment 10-feet LS of siphon breaker on LS slope. Recent road repair along the approximate pipe alignment suggests that levee slumping is related to pipe. It is recommended that further investigation e.g. video inspection or other internal method may help determine if the issue is due to pipe or due to levee settlement in vicinity of the pipe. (T. Hatch/UCIP) FIELD_STRUCT_DESC: 18-inch steel irrigation pipe through the levee, 3 feet below the crown. Pump mounted on a piling structure on the waterside (WS) bank. A switch box is located on the WS shoulder and a siphon breaker is in a 30-inch corrugated metal riser on the landside (LS) shoulder. Pipe discharges into a concrete box at the toe of the LS slope (Permit issued under ABO No. 9349, 1974 - Davis). Pump and pump platform replaced under Permit No. 5551, 1968 - Davis. Fish screen installed under permit No. 17222, 2000- A&L Rental and Leasing . [Additional Reference(s): DWR Levee Logs, 2006]. FS Date: 9/23/2016

Siphon Breaker in 20-inch CMP riser on LS Shoulder. Photo taken from LS looking DS along Moon Bend Rd

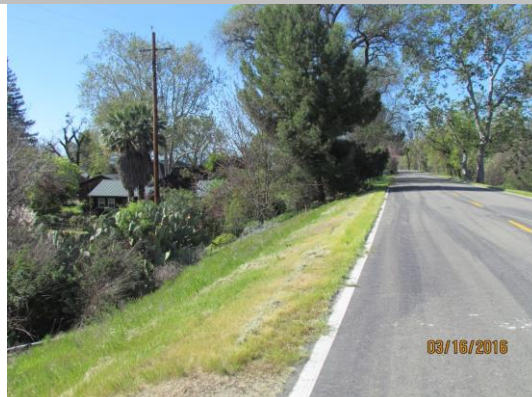
Photo 1 of 1 : FA_2016_NA0016_435_54_20160913_00030.jpg

LM Start	47.01	Rating **	M	Issue No.	54
LM End	47.14	Issue Type +	En	Location *	LS
Category	Earthen Levee			GPS Latitude/Longitude	
				Start	End
Item	Vegetation			39.188544 °	39.189733 °
				-121.979272 °	-121.981232 °
DWR ID	DWR_NA0016_01_s_ 2012_54				
Comment Code					
V6 : Landscaping					
Inspector Comment					
Cactus on slope and toe of levee, landscape continues along roadway with fence and stairs.

View of the revegetation on the landward side of the levee looking upstream. Spring 2016.

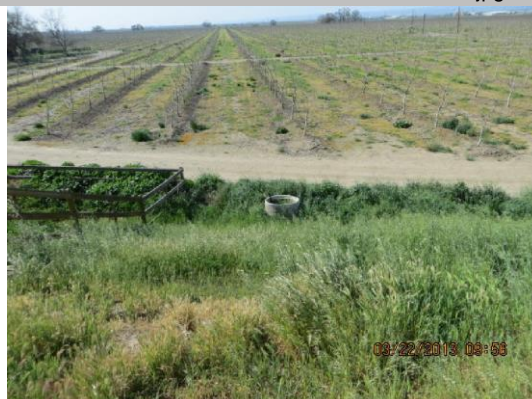
Photo 1 of 1 : UCIP_FA_2016_10553_17929.jpg

LM Start	47.16	Rating **	M	Issue No.	1552
LM End	47.16	Issue Type +	En	Location *	LS
Category	Supplemental			GPS Latitude/Longitude	
				Start	End
Item	DWR UCIP Field Study			39.189783 °	39.189783 °
				-121.981548 °	-121.981548 °
DWR ID					
Comment Code					
Inspector Comment					
FS_ID:10553					
DS_ID:20298					
EP_NO: 9347					
Repair Type: Non-Urgent					
Crossing Status: Indicator Found					
UCIP Comments: Need to verify type of abandonment.					
FIELD_STRUCT_DESC: 1 of 2: 24-inch pipe through levee 25.5 feet below crown. 14-inch pipe sleeved through this pipe. Annular space grouted. Pump in pump house on the landward side. Gate valve in pump house (ABO No. 9347, 1960). Originally included in the 1960 O&M manual.					
FS Date: 3/22/2013

Possible location for pipe crossing.

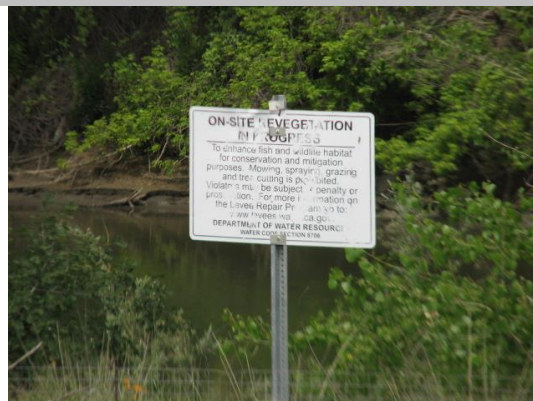
Photo 1 of 1 : FA_2016_NA0016_435_90_20160913_00038.jpg

LM Start	47.19	Rating **	A/W	Issue No.	90
LM End	47.62	Issue Type +	Ob	Location *	WS
Category	Earthen Levee			GPS Latitude/Longitude	
				Start	End
Item	Vegetation			39.189930 °	39.193491 °
				-121.982143 °	-121.988184 °
DWR ID	DWR_NA0016_01_s_2014_90				
Comment Code					
V8 : Environmental Requirements.					
Inspector Comment

A revegetation site along the waterside berm. Spring 2014

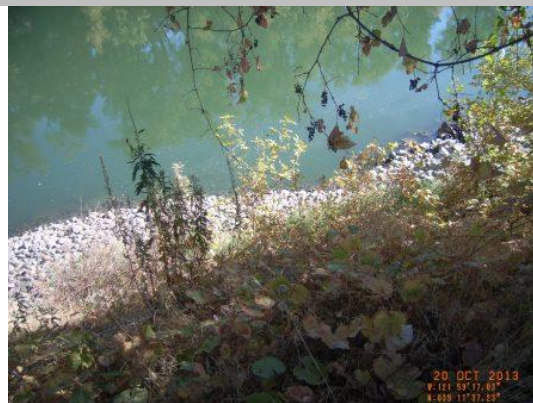
Photo 1 of 1 : FA_2016_NA0016_435_3_20160913_00003.jpg

LM Start	47.62	Rating **	A/W	Issue No.	3
LM End	47.77	Issue Type +	Ma	Location *	WS
Category	Supplemental			GPS Latitude/Longitude	
				Start	End
Item	2015 USACE Erosion Survey, DRAFT			39.193769 °	39.195595 °
				-121.987901 °	-121.988621 °
DWR ID	DWR_NA0016_01_s_2016_3				
Comment Code					
Inspector Comment					
2010 - Old cobble site starting to unravel at toe. 2011 - Cobbles continue to unravel. 2013 - Site extended downstream to revetment. 2015: No observed changes. [2015 Site ID: SAC_141-5_R]

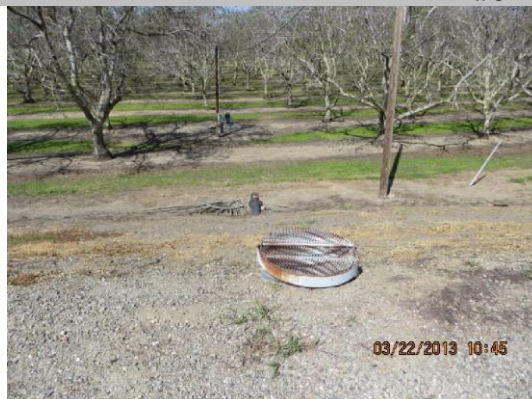
Photo 1 of 2 : UCIP_FA_2016_10566_17954.jpg

LM Start	48.38	Rating **	M	Issue No.	1577
LM End	48.38	Issue Type +	En	Location *	WS
Category	Supplemental			GPS Latitude/Longitude	
				Start	End
Item	DWR UCIP Field Study			39.203761 °	39.203761 °
				-121.985220 °	-121.985220 °
DWR ID					
Comment Code					
Inspector Comment					
FS_ID:10566 DS_ID:20300 EP_NO: 9343 Repair Type: Non-Urgent Crossing Status: Found UCIP Comments: Pipe appears to be abandoned. Need to verify type of abandonment. FIELD_STRUCT_DESC: 2 of 2: 24-inch pipe through levee 15.5 feet below crown (pipe measures 12-inch on LS toe). Slant pump on steel piling structure on the waterward bank. Butterfly valve at toe of the landward slope. Overhead power line crosses the levee. (ABO No. 9343, 1960) Originally included in the 1960 O&M manual. FS Date: 3/22/2013

Siphon Breaker in 30-inch CMP riser on LS shoulder and butterfly valve at LS toe.

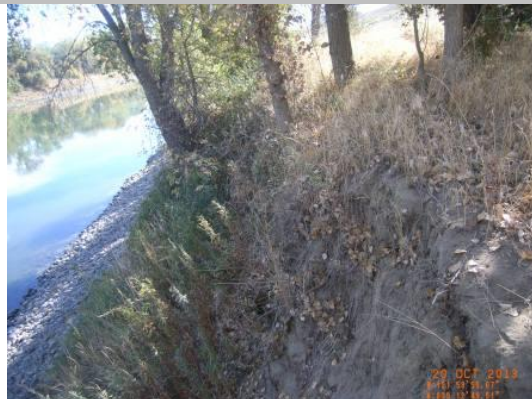
Photo 1 of 1 : FA_2016_NA0016_435_19_20160913_00018.jpg

LM Start	49.46	Rating **	M	Issue No.	19
LM End	49.57	Issue Type +	Ma	Location *	WS
Category	Supplemental			GPS Latitude/Longitude	
				Start	End
Item	2015 USACE Erosion Survey, DRAFT			39.213608 °	39.213869 °
				-121.997543 °	-121.999641 °
DWR ID	DWR_NA0016_01_s_ 2016_19				
Comment Code					
Inspector Comment					
2011 - Multiple scallops, one tree pop out. Old cobble site starting to unravel at midbank. 2012 - Mid bank slumping continues to worsen but cobble at the toe appears stable. 2015: No observed changes. [2015 Site ID: SAC_143-5_R]
